Autumn Woods Update on the Lakes Improvements--Notice 7

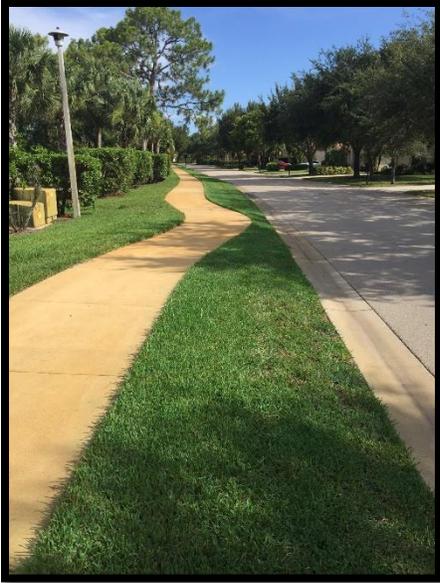
Those of you living North of Red Oak Boulevard are no doubt aware of the rust stains created by irrigation water drawn from the lakes. The cause is from iron in the water that, when exposed to air and moisture, oxidizes or rusts. Our irrigation contractor (Stahlman-England) has tested the water and iron levels in lakes #7 (the lake from

which we draw irrigation) and found the iron concentrations at 0.17ppm; below what typically causes staining (0.30 ppm is the threshold where staining usually occurs). The most likely cause of iron concentrate in our water is a result of having the irrigation intakes too close to the bottom of the pond, where iron settles, is concentrated and then pulled off the bottom of the pond.

Figure 1: Picture above depicts rust staining on sidewalk along Autumn Woods Blvd caused by iron in the lake irrigation water.

The Board recently approved to have Stahlman - England adjust the depth of our irrigation intake, so that it is 18 to 30 inches below the water surface. We have also prioritized installation of aeration diffusers in lake #7 to help reduce the iron concentrations further. As of yesterday - Aeration is up and running in Lake #7. We've also tested the concentration of iron in lake #13 - the one lake at Autumn Woods that has had aeration for several years - and found the iron concentration is at 0.04 ppm which is a very low concentration. The work on lifting the irrigation intake off the bottom of Lake #7 is expected to be completed in the next two weeks and shortly afterward we are hoping to see notable reduction in iron staining.

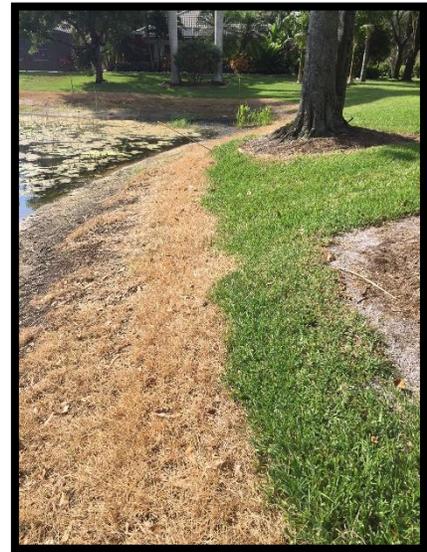
The installation of plants around the lakes is only about 50% complete. The lake contractors were on hold until the water levels rose to a level that would help the littorals take root. Planting will begin again next week and we expect to have all planting done by the end of August. Please contact our Property Manager Tony McHugh at 596-9634, or tmchugh@resortgroupinc.com to answer any questions, or concerns that you may have. *Figure 2: Picture to the right depicts unplanted lake bank where native grasses will be planted through the dead grass.*

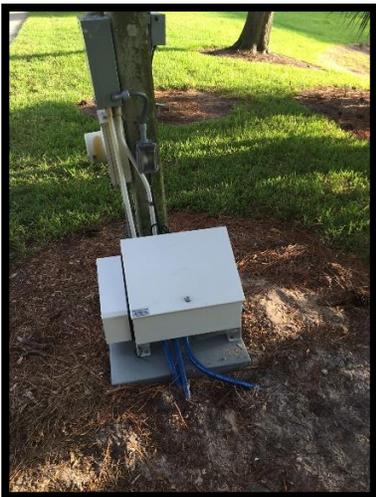
Figure 3: Picture of electric compressor equipment that will provide air to the lake diffusers via air tubes. Lake diffusers (bubblers) will be located at the bottom of the lakes.
